**TECHNICAL REPORT TOWARDS THE FIRE ACCIDENT
OCCURRED ON 11.08.2023 IN QUALITY ASSURANCE
LABORATORY INSIDE THE PREMISES OF BBMP HEAD OFFICE**

Ref: Hon'ble Chief Commissioner, BBMP office order No.BBMP/CC/PR
/118/2023-24, dated:11.08.2023

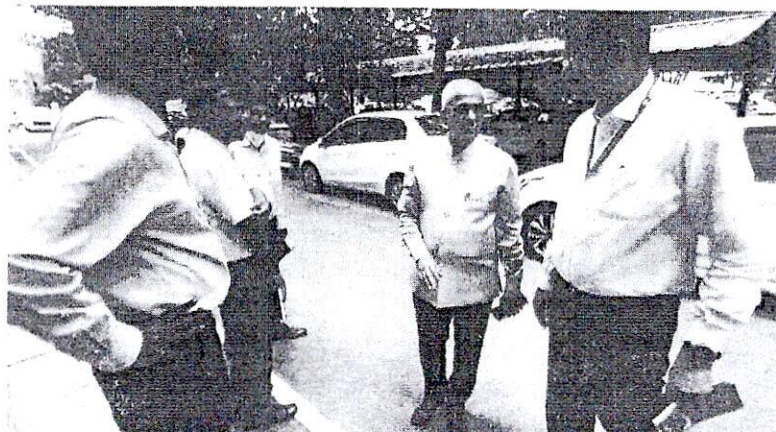
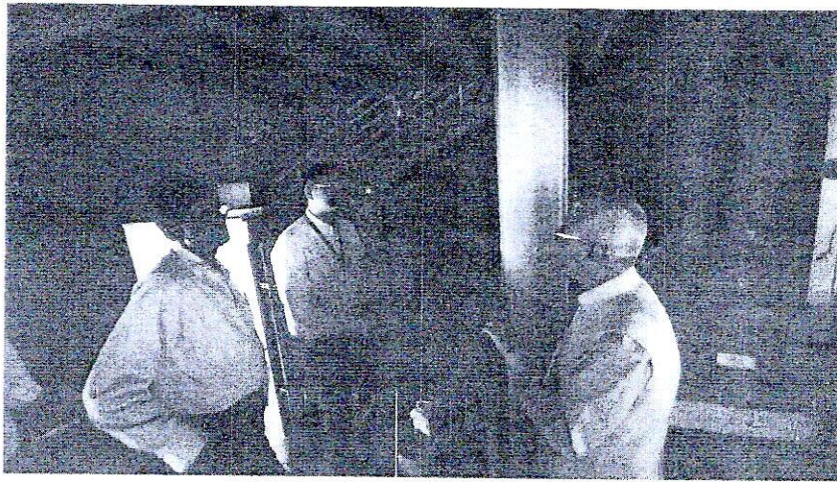
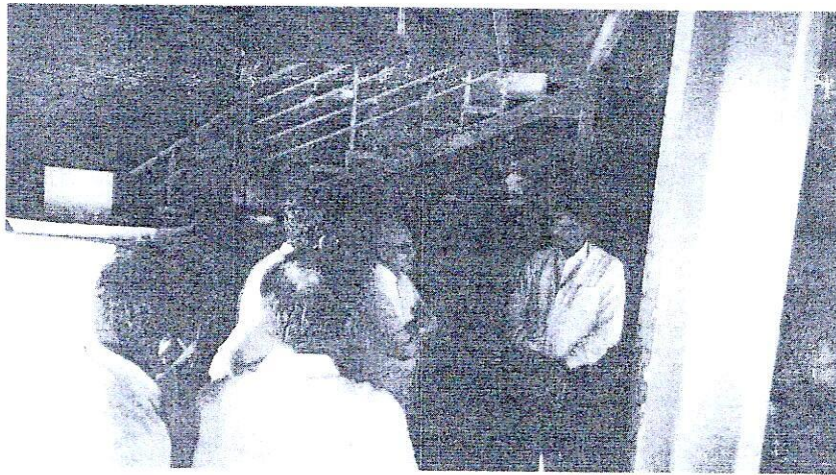
The photographs showing the visit made by the Principal is as below:

The Experts jointly opined that, the laboratory is housed in a very small space and is not adequate as per standard specifications. They informed that, there should be circular space around each equipments for each person working on the equipments during conducting the tests. In the present instance they opined that, the equipments in the laboratory are cramped and there is not even lateral space between the two equipments for a person to handle the equipments properly.

The experts also opined that, the mezzanine floor constructed out of steel fabrication over the laboratory is an ill-conceived idea. It was also opined that, the height of the laboratory roof should have a minimum height of 3.75m to 4.0m (12ft to 14ft) with cross entries and ventilation.

The experts opined that, small windows have blocked the free passage of smoke that has erupted due to fire. They concluded that, the laboratory should be immediately disused.

1. The laboratory situated in the BBMP head office premises, may be disused and new laboratory block may be constructed within the head office premises in the space available in front of "Naukara Bhavana".
2. The ground floor and the mezzanine floor may be used as "Office Space". The windows which are 1.2m x 1.2m of size may be altered to minimum 1.8m x 1.2m.
3. The equipments in the laboratory are in very good condition and laboratory block should be constructed so as to re-install the available equipments without any damage.
